A low cost lightning protection system and its effectiveness

By: Nuwan Kumarasinghe

Abstract

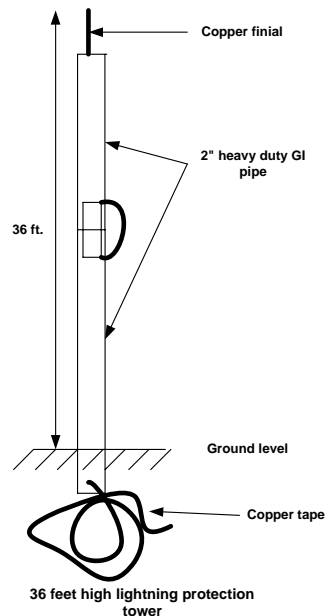
A 36 ft. high G.I. pipe based tower together with copper air termination was used. Roughly about 275 US\$ would cost for such a protection tower. A total of 27 such lightning protection towers were installed in *Janahitagama* village. Villagers helped the technical staff of the department for the installation.

Fig. 4 Lightning protection tower

Among the factors considered for the design were; number of thunder days in the area, soil resistivity and soil type. Number of average thunder days in this area is about 130. As the soil type was gravel, sandstone with little clay, soil resistivity value was taken as 2000 ohm-m. In some places one lightning protection tower covers more than houses.

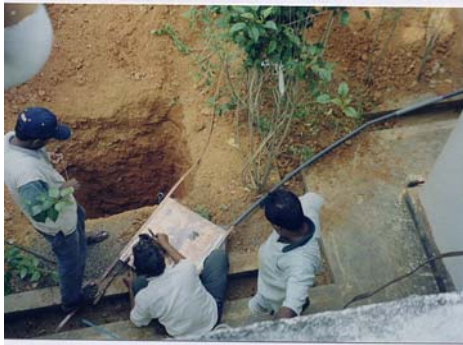
Coco peat has been introduced to the earth pit before install the earth electrode or rod.

Fig. 5 Earth electrode installation

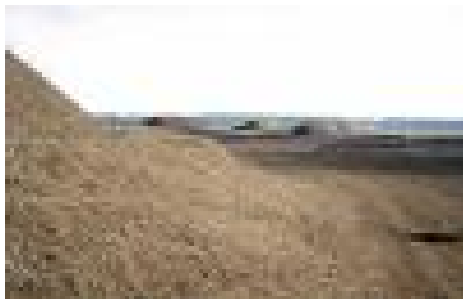
Coco Peat (cocopeat), also known as coir pith or coir dust, is a byproduct of extracting fibres from the husk of a coconut. Coco Peat holds water rather

than shedding it like traditional peat does! It holds 8-9 times its weight in water. Coco Peat is very slow to disintegrate; it only begins to break down when it is 10 years old, long term benefits.

Fig. 6 Coco peat

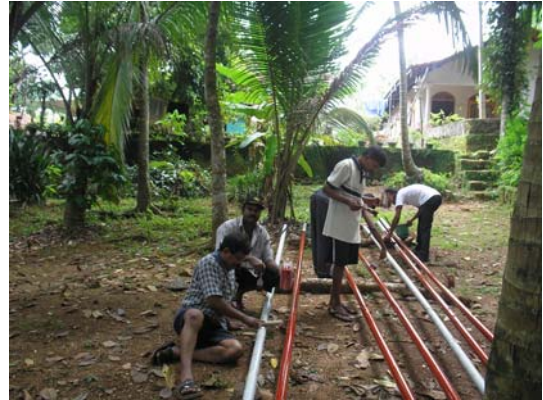
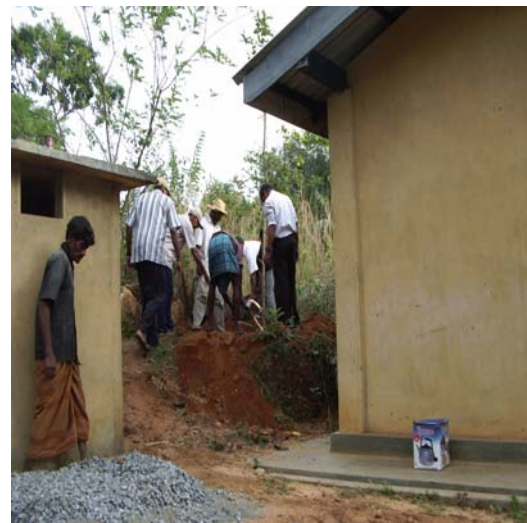
Fig. 7 Installation of lightning protection towers

Out of 27 lightning protection towers installed in the entire village, earthing arrangement of the 3 towers was done with coco peat and another three towers were done with paddy dust or rice hulls. *Bentonite* was used for the rest of the towers.
